# STRUCTURAL QUALITY CONTROL IN THE FIELD

#### Abstract

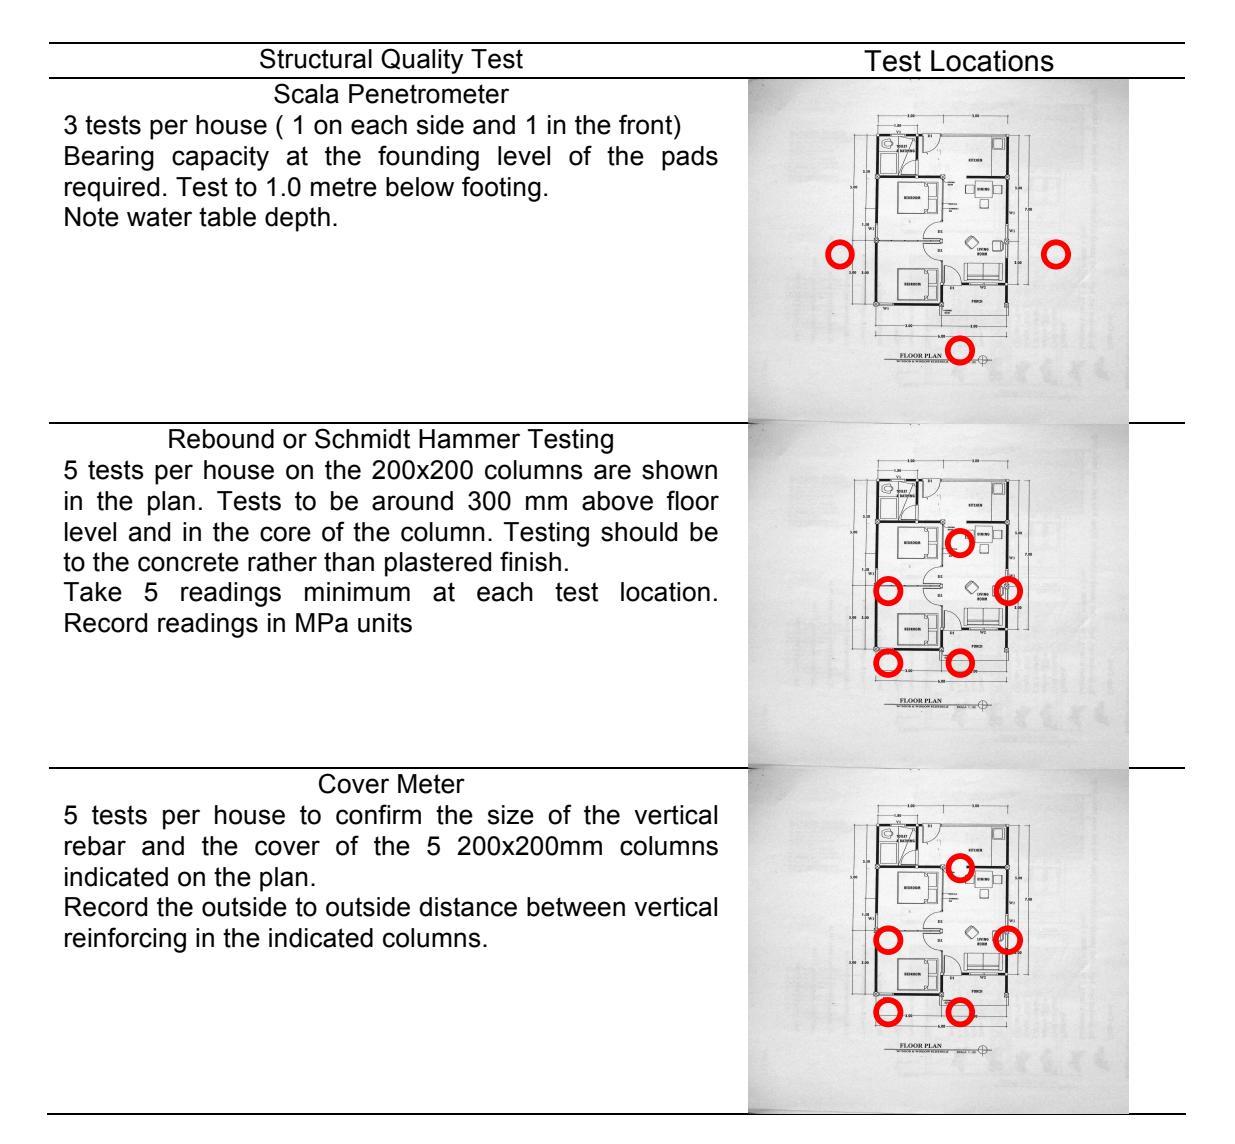
# Table 1: Test Locations

These were measured at the sites identified in table 1.

Insufficient soil bearing capacity at any one of the three test locations constituted a fail and a recommendation to demolish regardless of the other test results. If that was not the case then the house needed to achieve at least three passes from the five test locations for the remaining two tests to pass.
