## Understanding Patterns of Physical Transformation in Reconstructed Settlements: the Case of Post-Earthquake Housing in Marathwada, India

### Abstract

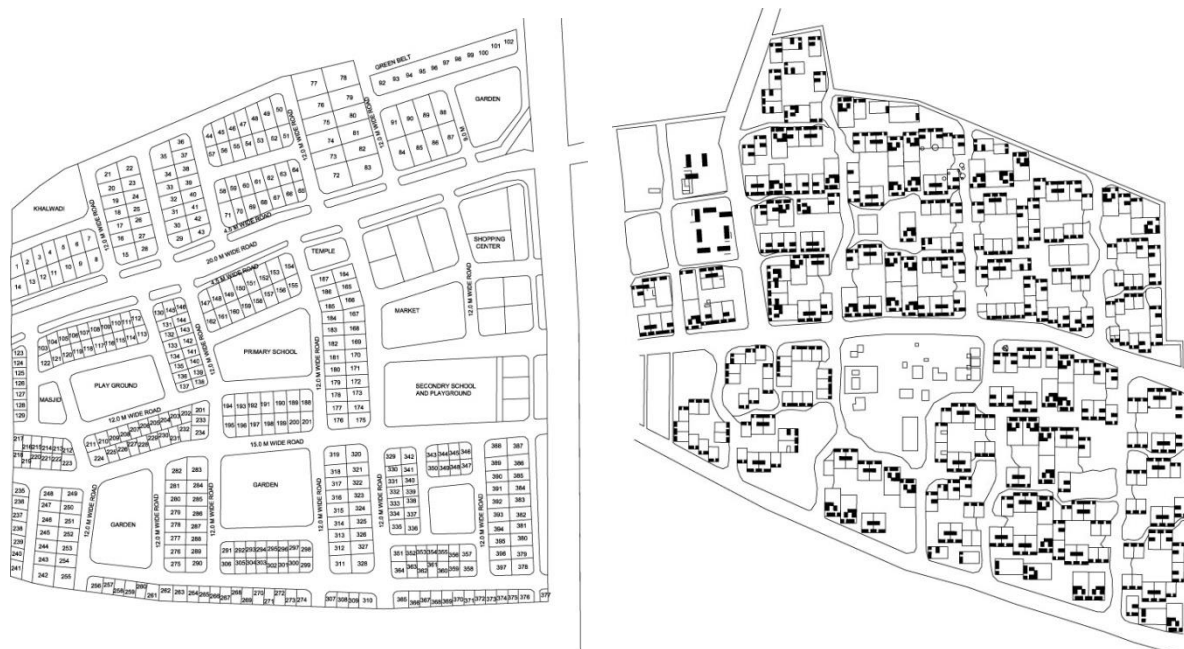
Figure 1: Left: relocated village of Sirsal's grid pattern layout; plan of 1996. Right: relocated village of Malkondji's cluster type layout; plan of 1996. Source: MEERP, 1996.

The planning of relocated settlements was taken up by various donor and government agencies and consequently many different layouts and designs were explored of which the most common was a grid iron pattern (fig. 1 left). While traditional settlements were characterised by narrow streets, a hierarchy of public and private open spaces used for religious as well as other activities, clusters of housing with distinct typologies were characterised by traditional occupation patterns. However, in most of the cases, what was designed for them was a complete 'city-like' plan with wide streets forming a grid pattern, and row housing. Only in some rare instances was cluster-type planning done (fig. 1 right), supposedly inspired by the traditional village layout (fig. 2) (Jigyasu, 2001).

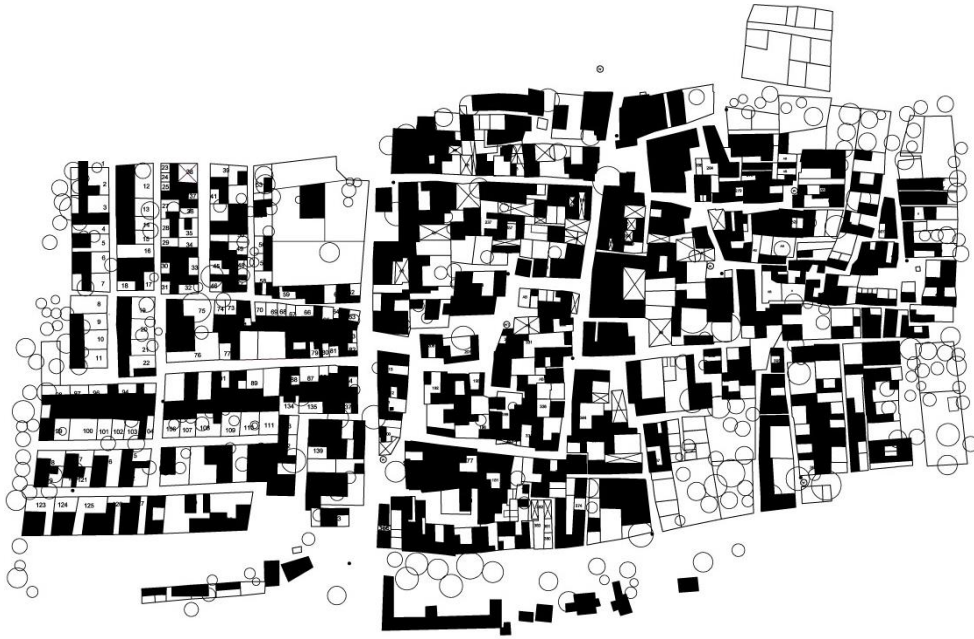
Figure 2: Traditional village of Almala's organic layout. Source: Authors, 2011.

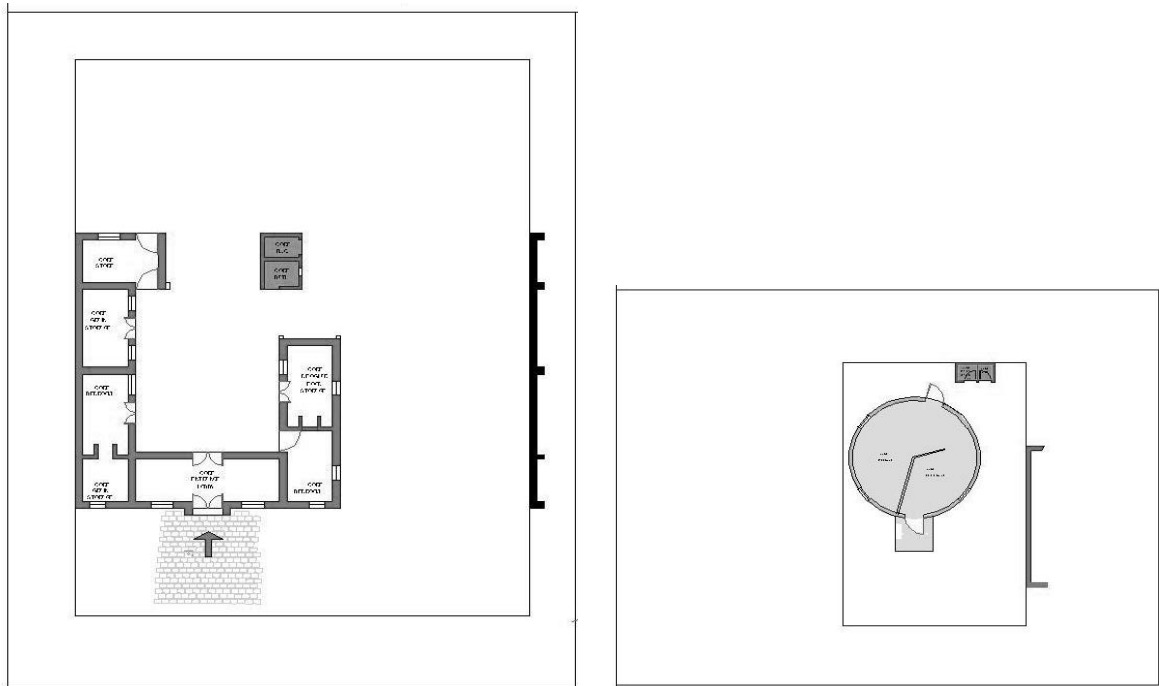
Figure 4: Left: Category C house in Gubbal with the Introvert plan of the house based on vernacular architecture, built by the Government of Maharashtra. Source: Authors, 2011. Right: Category B house in Gubbal, with circular plan and ferrocement partitions inside to divide the living spaces, built by AADRA. Source: Authors, 2011.

Various designs of three sizes were proposed for the reconstructed dwelling units. Sizes were decided based on the size of the land owned by the affected family. The basic design of the house was, in some cases, very comparable to the traditional Wada, while certain designs bore no resemblance to the vernacular architecture. In Gubbal, two such extreme cases could be observed, where the Government of Maharashtra constructed houses with close resemblance to the vernacular architecture (fig. 4 left) while the donor agency AADRA created earthquake resistant ferrocement domes (fig. 4 right), a completely alien technology and shape for the region of Marathwada.

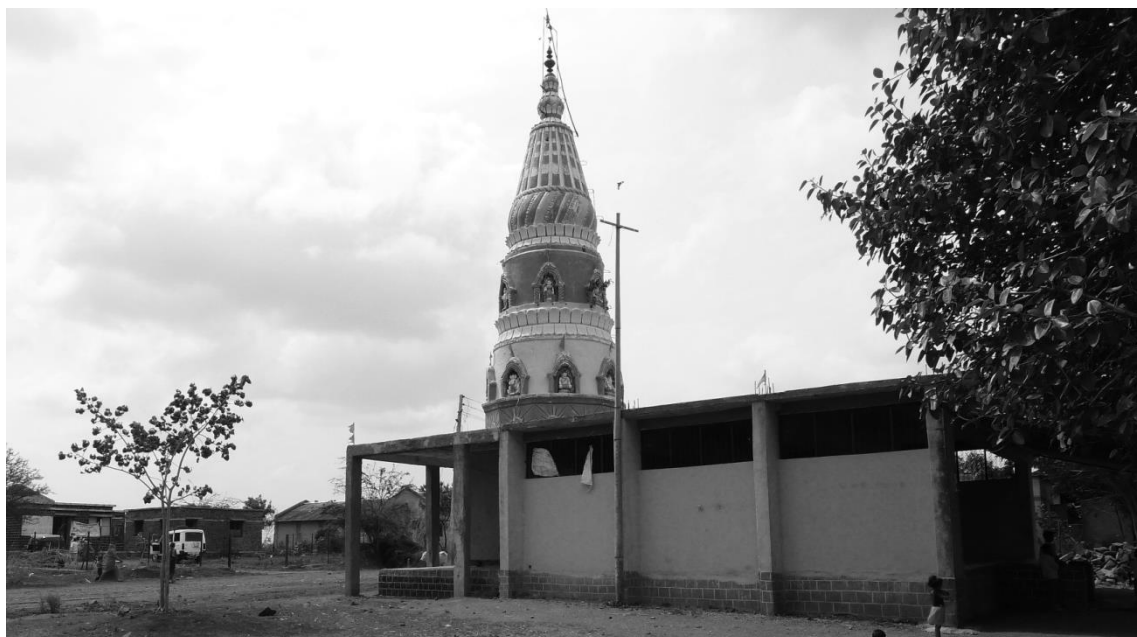
Figure 5: Temple in Sirsal. Source: Pittet, 2011.

In many relocated villages, temples and mosques have been added through joint efforts of the community. For instance, the Sirsal Temple was constructed jointly by inhabitants and the village panchayat (the local governing body) with an elaborate spire (fig. 5). It is dedicated to Lord Shiva and used by the Hindu community for religious and cultural gatherings.

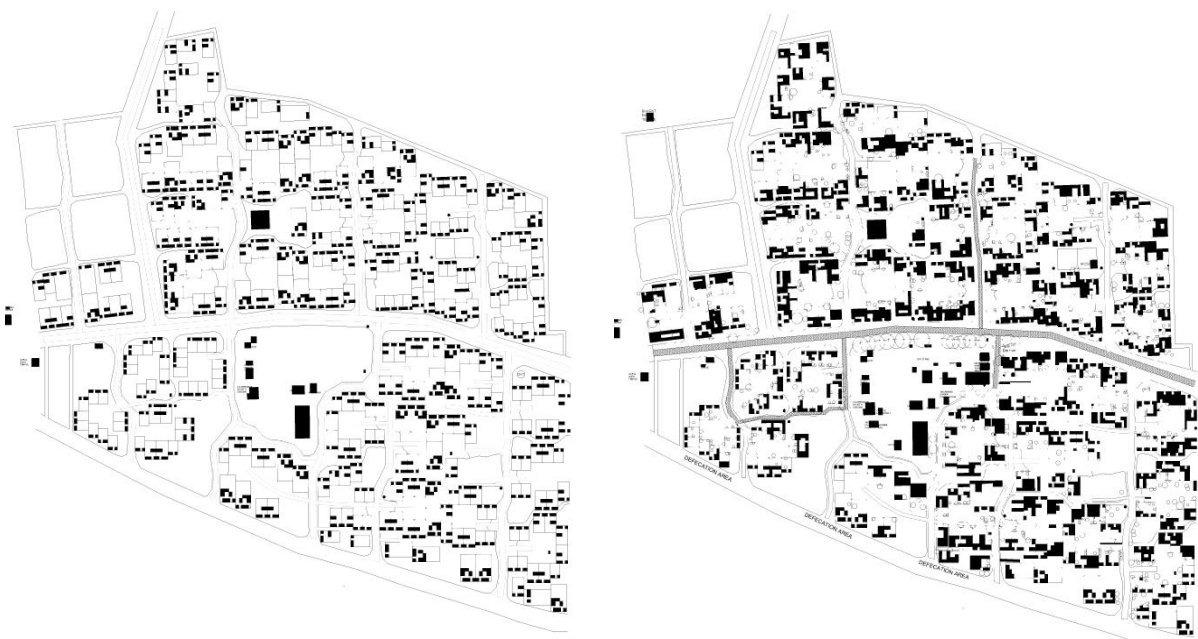
Figure 8: Malkondji village density. Left: at the time of reconstruction; Right: in 2011. Source: Authors, 2011.

The relocated settlements have not changed in their overall size, but have densified inwards (figs. 7, 8). Therefore the built area within the village increased as the families expanded. This is because of the availability of larger plots in relocated villages that allowed people to make extensions to their core houses.

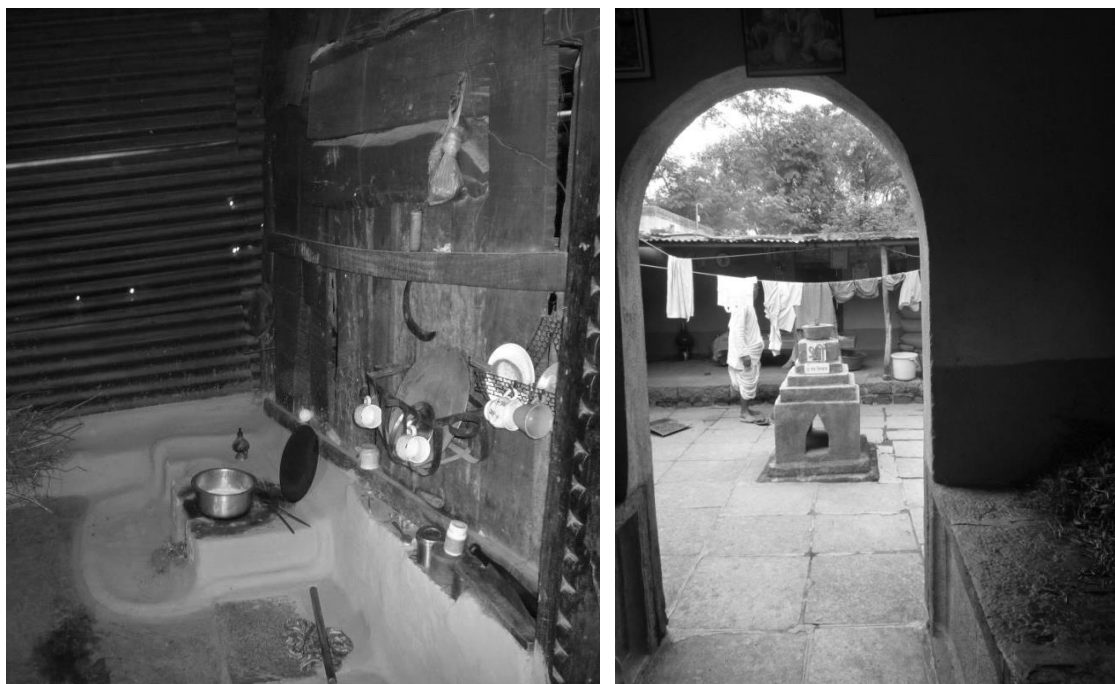
Figure 9: Left: Extension to accommodate the kitchen; Right: Extension for Dhelaj. Source: Authors, 2011.

In all of the case studies, the space immediately added to the original structure is a kitchen. In fact, the core house design clearly does not consider the rural ways of cooking food, as they lack a chimney for the smoke produced during cooking food on conventional Chulha (firewood stove). Therefore, the first post-relocation extension was the construction of a kitchen (fig. 9 left), followed by the construction of a storage space, a Dhelaj (elaborate threshold of a traditional wada house) wall (fig. 9 right) and a toilet.

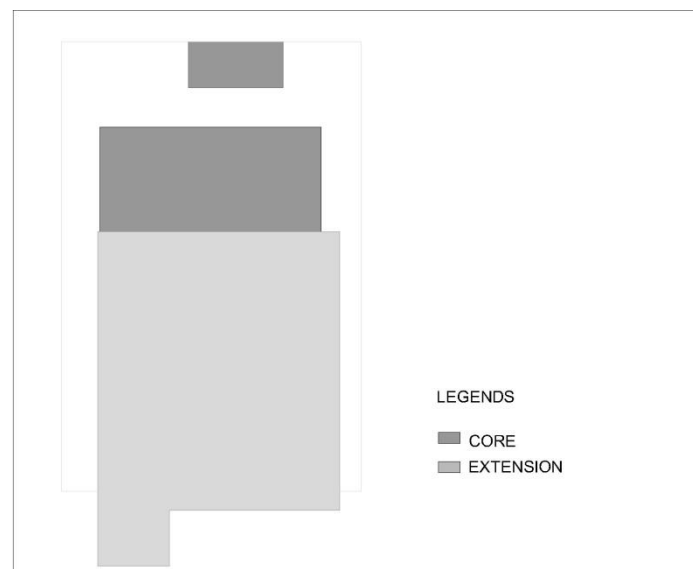
Figure 10: House in Sirsal. Core block at the center of the plot. Source: Authors, 2011.

The location of the core house in the open plot is also a very significant factor that determined the pattern of later extensions. The plots where houses were located at the extreme end proved to be the most convenient for extensions, while those having the built blocks placed in the middle of the plots were not suitable for extensions. In such cases, the rear of the plot could not be used due to inaccessibility, and so the extensions were built in the front, often encroaching upon the public land beyond the plot boundary (fig. 10).

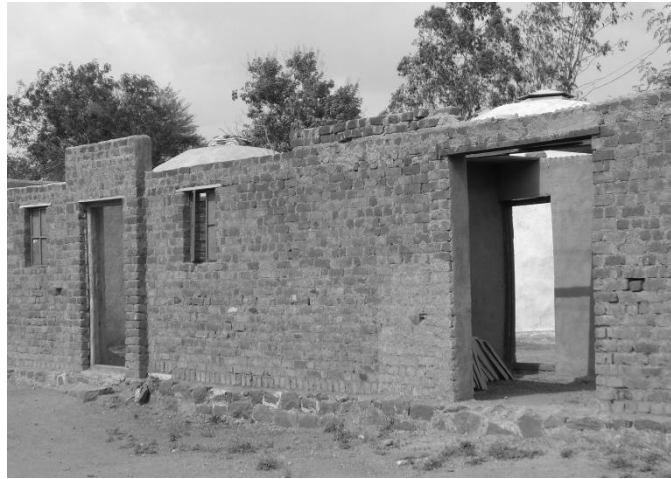
Figure 11: Extensions around the dome house in Gubbal, hiding the dome from the view.  
Source: Upadhyay, 2011.

In the case of Gubbal, the circular plan and the curved ferrocement walls made it impossible to make strong extensions that were integrated with the core units. However, it allowed the villagers to make the extensions around the dome completely surrounding it and creating an intimate open space in between the dome and these extensions (figs. 11, 12). In many such cases, the house entrance with dhelaj (platform for sitting on both sides) often looks like a typical Wada style house.

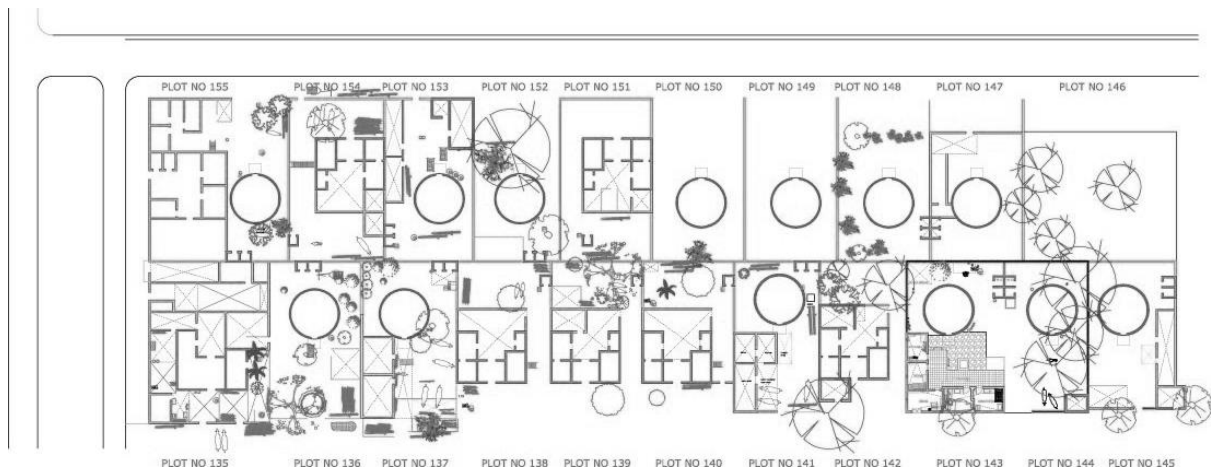
Figure 12: Extensions around the core houses (domes) in the relocated village of Gubbal.  
Source: Authors, 2011.

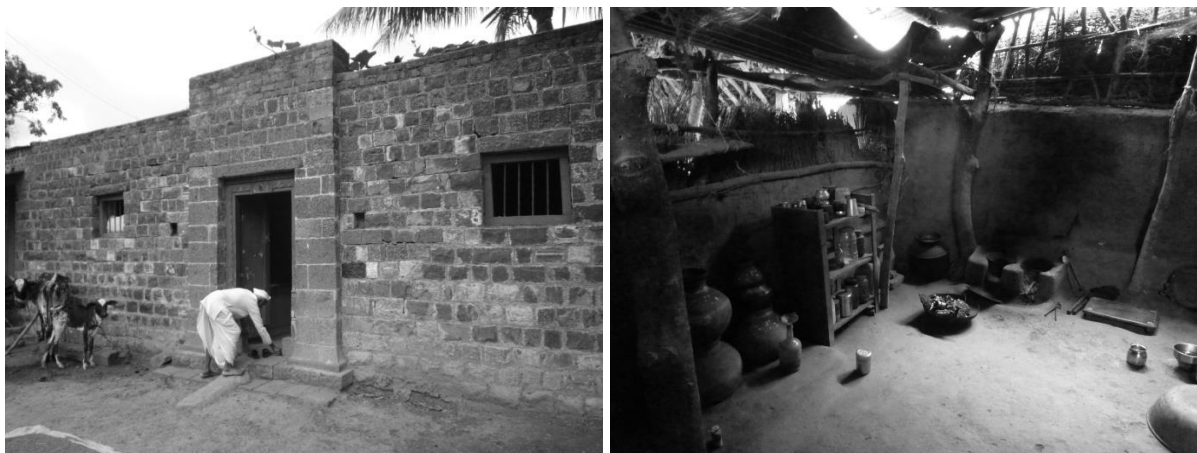
Figure 13: Left: Lingayat house with elaborate stone and brick extension; Right: Mahar house with wattle and daub extension. Source: Authors, 2011.

The use of a certain material of construction also depends upon the socio economic status of the house owner. For example, in Malkondji it was observed that Maratha, Brahmin, Lingayat and Muslims used stone or brick for the extensions (fig.13 left), whereas other castes like Maang and Mahar were seen to be using wattle and daub to create partition walls in extensions undertaken in their houses (fig. 13 right).

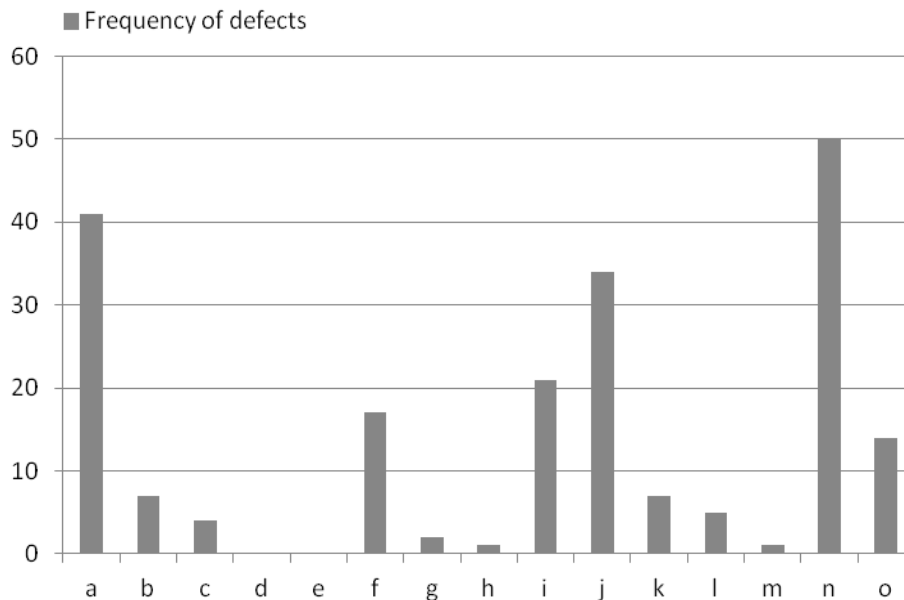
Figure 14: Frequency of defects in studied houses in the relocated villages.

A radical shift in material and construction techniques has also affected the vulnerability of the houses and their residents. To illustrate, 26 case studies were chosen as samples from the three relocated villages to identify the houses’ vulnerability patterns. Figure 14 shows what type of defects and their frequency were found there.

The absence of lintel band or its discontinuity, hybrid use of materials for walls and improper brick masonry were found as the most recurring defects in the houses, which contribute to their seismic vulnerability (figs. 15 left and right).

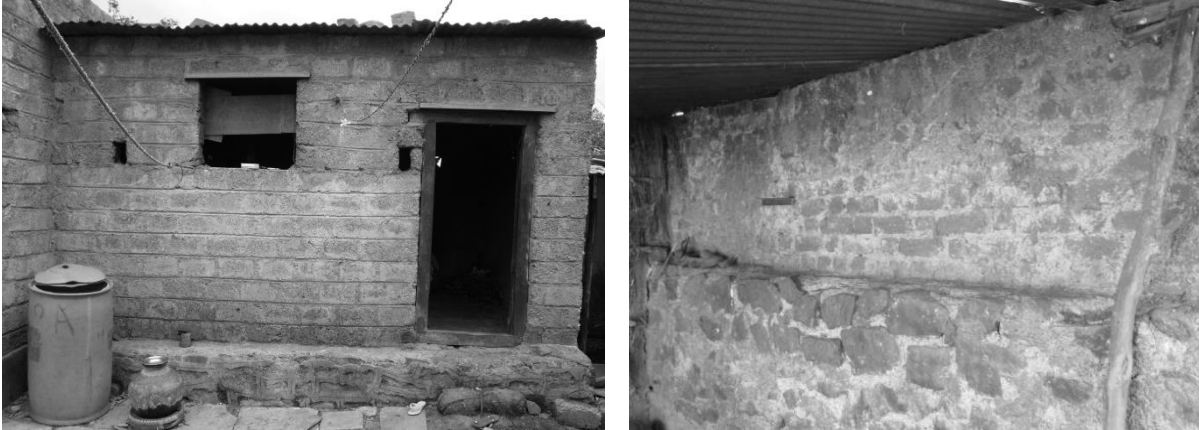
Figure 15: Left: Muslim farmers' house in Gubbal made of independent brick structure of high walls without horizontal tie band; Right: Dhangar house in Gubbal made of hybrid material walls. Source: Authors, 2011.

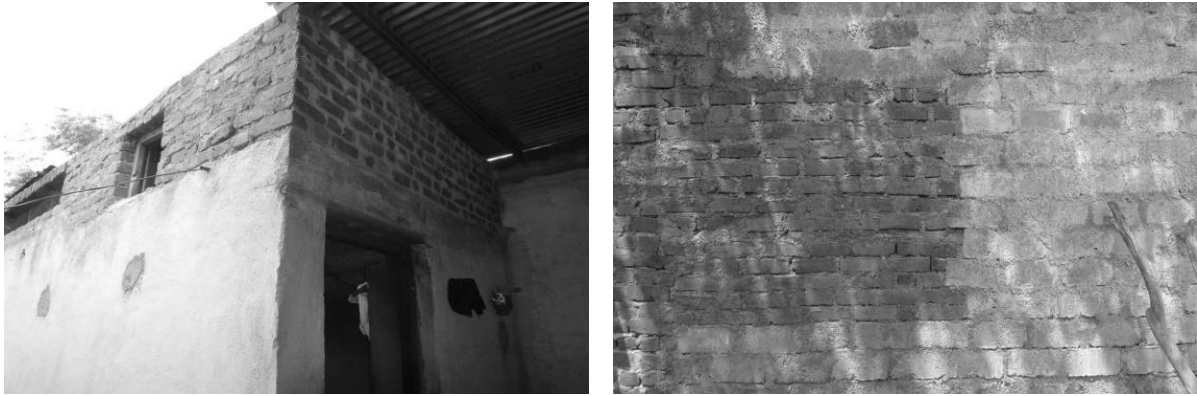
Figure 16: Left: High masonry walls lacking lintel bands in a Muslim farmer family house in Gubbal; Right: Wall made of hybrid materials in a Maratha farmer family, in Malkondji. Source: Authors, 2011.

The Dome Houses in Gubbal are very stable structures, but not resistant enough to support any extension. Thus, the extensions built around them are independent brick masonry structures that lack continuous bands to stabilise their structure (fig.16 left). Also, their walls are constructed in poor masonry using hybrid materials (fig. 16 right), thereby increasing their vulnerability to earthquakes.

People structure (fig.16 left). Also, their walls are constructed a strong but false perception that if they use brick masonry and tin roofs, the combination gives a sturdy yet light construction that will not collapse in the event of an earthquake. However, tin roofs become highly vulnerable to the strong winds in the area, and to reduce this vulnerability, roofs are tied down by heavy stones that prevent them from flying away. But in some cases, villagers just keep heavy objects and stones on weak tin sheet roofs, which make the house even more vulnerable.

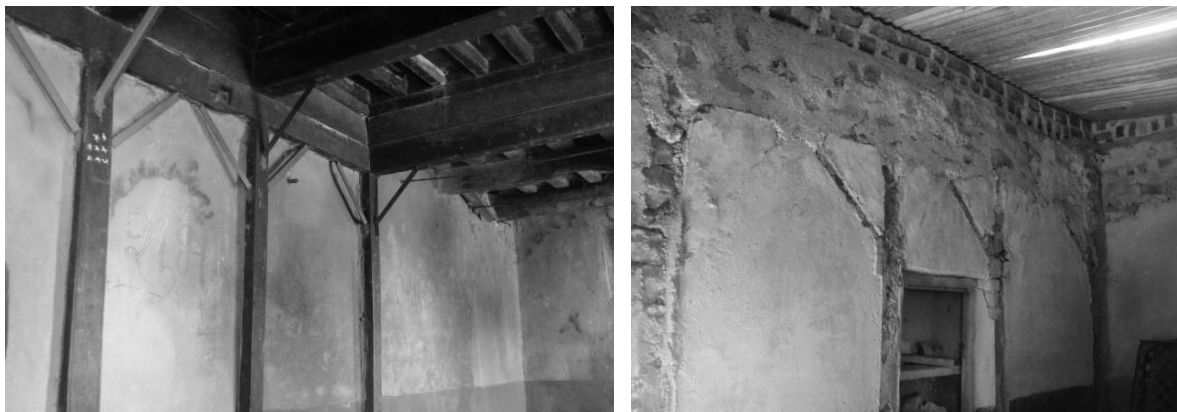
Figure 17: Left: Retrofitting technique used in Kharosa (C category village): wooden beams and posts tied through steel brackets; Right: Brackets introduced after the earthquake for retrofitting a traditional house have been removed by the owners to increase the height of the roof and replace Malwad with tin sheets. Source: Authors, 2011.

In C category villages, the houses were only repaired and retrofitted by government agencies and NGOs, as they did not suffer much damage from the earthquake. The traditional Malwad houses were strengthened by tying the whole wooden frame of beams and posts with L angle steel brackets (fig. 17 left). Despite training programs on retrofitting techniques for C Category houses conducted by some NGOs, most residents had not understood retrofitting basic principles and techniques. In one house, the owners had even removed these brackets in order to increase the height of the roof by making inappropriate additions to walls, and replaced the roofs with tin sheets (fig. 17 right).
