THE SEISMIC GAP:ISSUES OF SEISMIC DESIGN IN POST DISASTER RECONSTRUCTION

Regan Potangaroa, Dept of Architecture Unitec Auckland NZ.
potangaroa.regan54@gmail.com

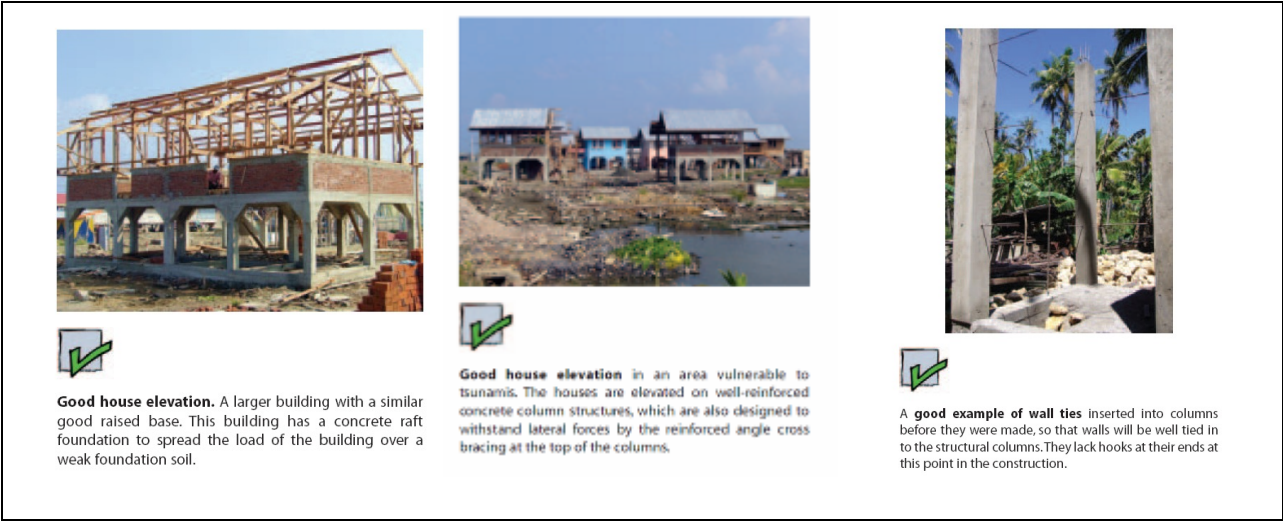
Fig. 2. Examples of Good Practice for Banda Aceh, Indonesia

The first in fig. 2 are of particular relevance as they are from an important UN guide on good building design and construction for Banda Aceh, Indonesia. The two on the left show a soft storey construction despite getting a green tick for the raft foundation on the left and being elevated in the middle photo. The middle photo gives a sense of the number of houses. The photo on the left got a green tick for tying the infill brick walls by steel rebar.

There is no consideration in these 3 photographs or their associated narrative of the impact of the soft storey or the infill brick on the seismic response of the buildings despite being in Indonesian seismic zone 5 that has peak ground accelerations of 0.29 to 0.36g. The site appears to be closer to 0.36g (flexible soils) than 0.29g (rigid soils). The knee stiffener in the concrete frame could also be problematic as it changes the structural action of the frame and depending on the selected R Value could result in shearing the column off at the base of the knee.

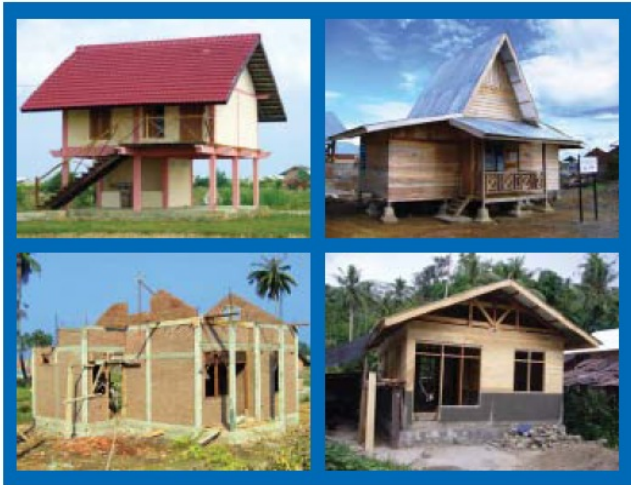
Fig. 3. Front Cover

The front cover of that same publication in fig. 3 below shows two further examples one (top left) of a soft storey that also has a torsional issue and (bottom left) a brick infill frame.

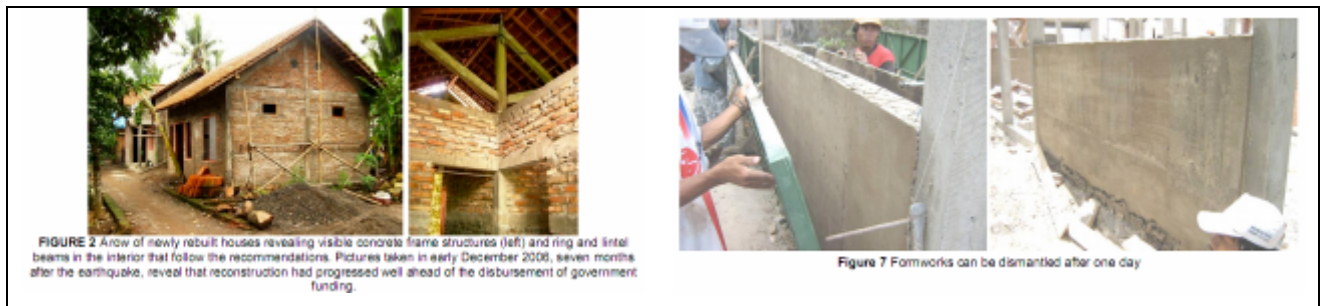
Fig 4. Reconstruction in Yogyakarta

The examples in fig. 4 are from another international organization. The narrative to the photograph on the left promotes the virtues of the local culture to “get on with the job” following the Yogyakarta earthquake. But they have apparently built back exactly what fell over in the earlier earthquake. The writer strangely also admits that additional unspecified bracing was added to the frame and that smaller vertical rebar and stirrups were used. That aside, it is another common example of brick wall infill and there was no reference on how the design may have been amended to prevent collapse in the next earthquake.

On the right of fig. 4 is a recycling example using brick rubble wall and cement mortar mix to construct infill brick/concrete walls. Other photos in the report show minimal reinforcing and while the use of rubble is a good idea the casting of the infill wall between the columns of the frame has the same effect as infilling with brick.

Both examples were aimed at mobilization of communities in post-disaster construction, which is excellent but probably lacked seismic expertise and input.

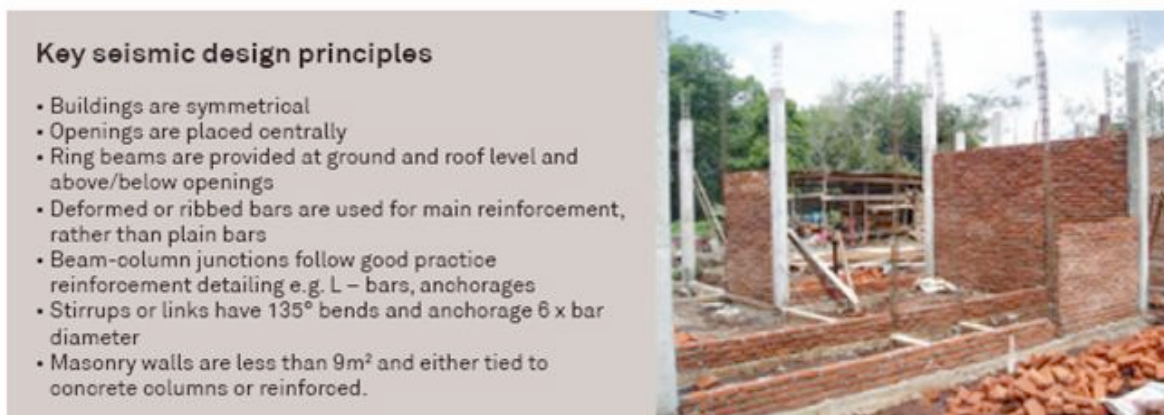
Fig. 5. Brick Infill Walls Engineering Advice

This final example in fig. 5 below, perhaps underlining da Silva’s observations for the need of engineers with seismic experience as it comes from an international engineering consultancy. While it contains good advice on the planning, materials and construction of the house it does not mention the need to review and ensure that the correct seismic load is used. As indicated earlier this can mean an increased seismic load of possibly 367% over a reinforced concrete frame and seems particularly relevant given the included planning advice.

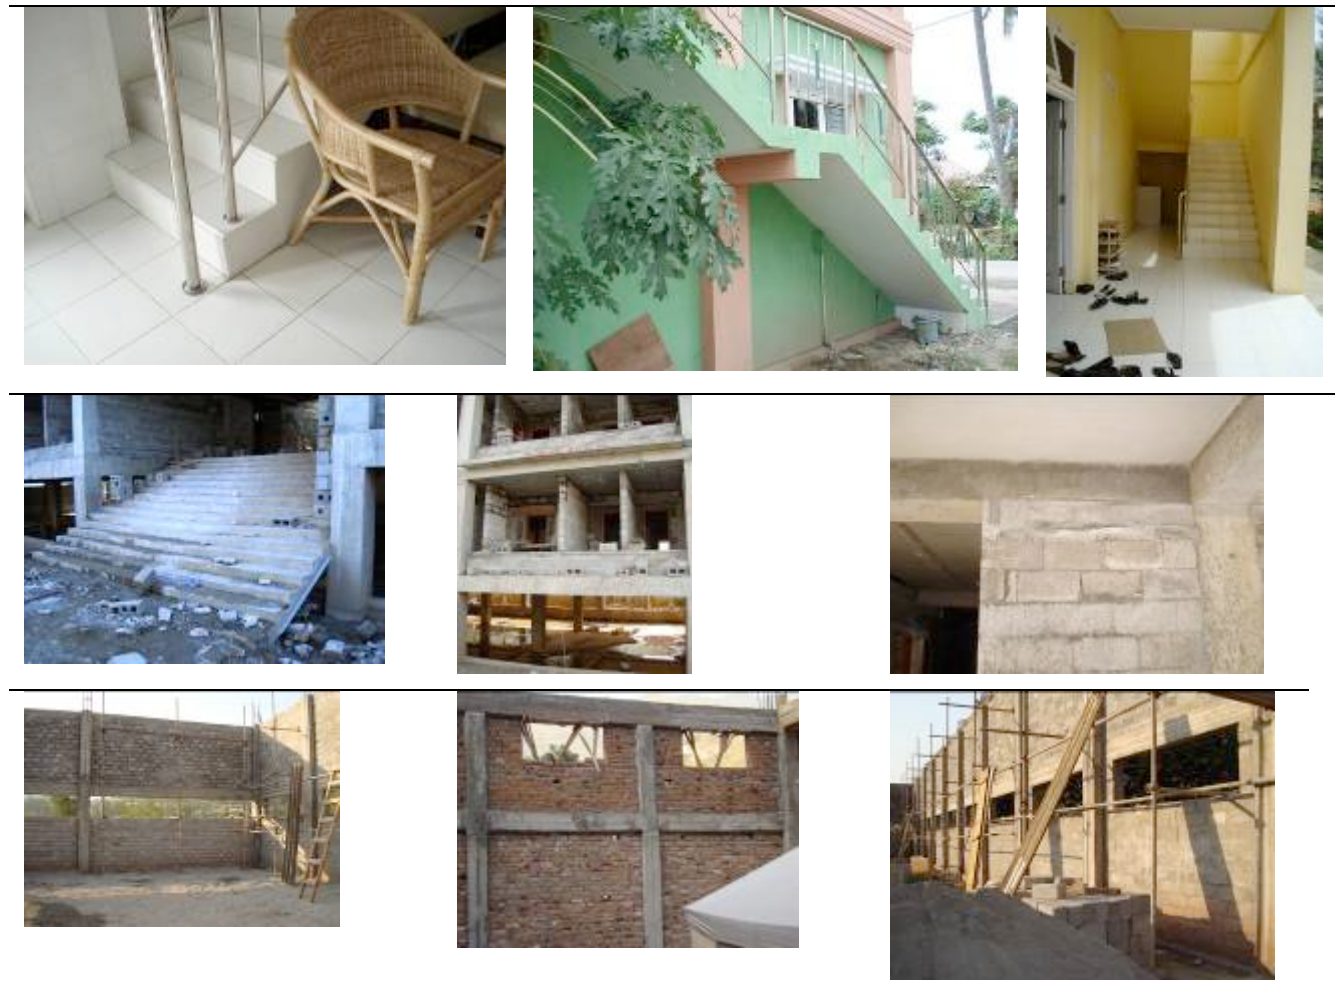
Table 3. Areas of “Unintentional” Seismic Construction

Finally, tabulated below in table 3 are selected photographs taken by the author on projects that he either worked on or inspected in the last five years. It was from these sorts of projects that the idea for the three specific areas of “unintentional” seismic construction originated. The first rows are examples of staircases tied into the structure that unintentionally brace their respective buildings, designed by a local consulting engineer. The hospitals or day clinics that would have been designed for a longer return period than the 500 years were usually adopted. These are in Indonesia.

In the second row, examples of a four story Government departmental building in Pakistan comprises all three of the specific areas. The reinforced concrete entry stair case is tied into the building (and also generates torsion within the building), it has a soft storey at ground level and the concrete block walls in the upper 3 floors are tied into the reinforced concrete frame structure of the building. An international engineering firm designed this building.

The third row shows examples of different larger infrastructure buildings in Pakistan such as power substations and key warehouses that have infill frames and soft storeys.
