STRENGTHENING OF HISTORIC BUILDINGS IN POST-DISASTER CASES

Banu Çelebiođlu* & Sevgül Limoncu
Department of Architecture, Yıldız Technical University

Abstract

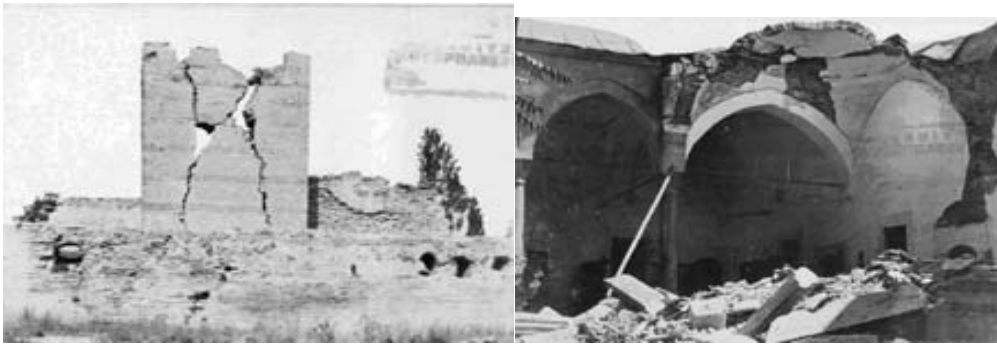
Figure 1. 1894 earthquake in Istanbul

When we observe the history of earthquakes in Istanbul, 13 severe earthquakes happened since the year of 325. In these earthquakes, while thousands of people had lost their lives, buildings are destroyed and there occurred giant waves and clefts in the ground. According to the information taken from Turkey Earthquake Charitable Foundation (TDV), there occurred 13 important earthquakes on the years 325, 427, 478, 865, 986, 1462, 1500, 1509, 1719, 1754, 1766 and 1894. In the 1894 earthquake, which is probably 7 on the Richter scale, the clefts were formed on the seaside, some parts of the ramparts and masonry buildings are destroyed but most of the wooden buildings are succeeded in standing (Figure 1).

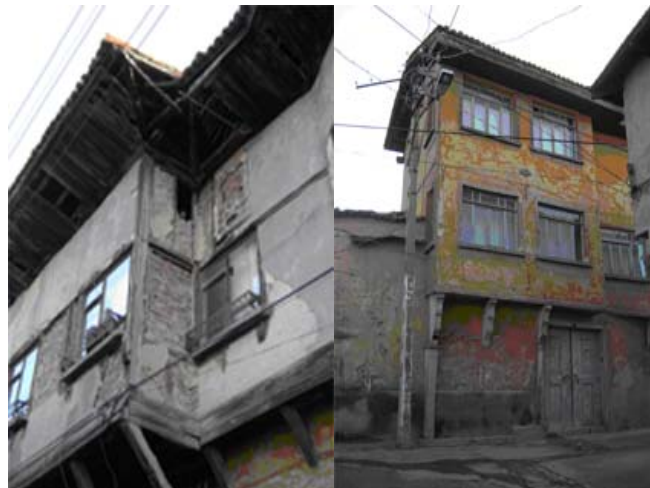
Figure 2. Examples of traditional houses that openings and construction systems have changed.

Another important point that should be taken into consideration is that the unconscious interventions, which are done by humans, destroy the structural continuity of the historical constructions. Especially in Istanbul, where the historical fabric is dense, by the increase of the commercial functions large openings are formed, the bearing components are removed or their order is changed in order to create a front for the shops on the ground floor. This intervention destroys the supporting system of the buildings and decreases its resistance against earthquake. In the upper floors, while window openings are widening, the distance between the corners of the buildings and the openings are decreased in the constructional system. Furthermore by making the distance of the spans wider, the system is changed and some of the diagonal braces and studs which are forming the timber frame are removed (Figure 2). By the way, the integrity of the construction is destroyed and it became non-resistant to the earthquake. This case suggests another point that should be cared: a control mechanism. Besides the conscientiousness of the traditional houses users, governments' supervision association should control the traditional buildings as well as the reinforced concrete buildings.

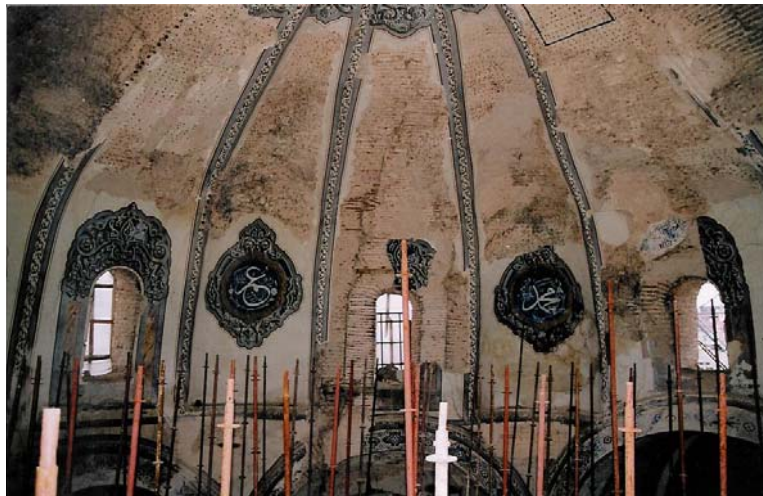
Figure 3. Cracks of the dome of the church Sergius and Bacchus

The earthquake of 1999 in Adapazarı caused major losses of human life (30.000 people) and severe damage and destruction of the architectural heritage. The same earthquake had also important effects in Istanbul. Hagia Sophia, Sergius and Bacchus, Edirnekapı Mihrimah and Fatih Mosque were among the seriously affected great monuments (Figure 3). Great monuments show different problematic of their own and it is impossible to generalize strengthening methods. There are many criteria for them and each case is unique. Whenever an earthquake occurs we give more importance to the great monuments rather than the vernacular architecture which constitute the urban fabric.

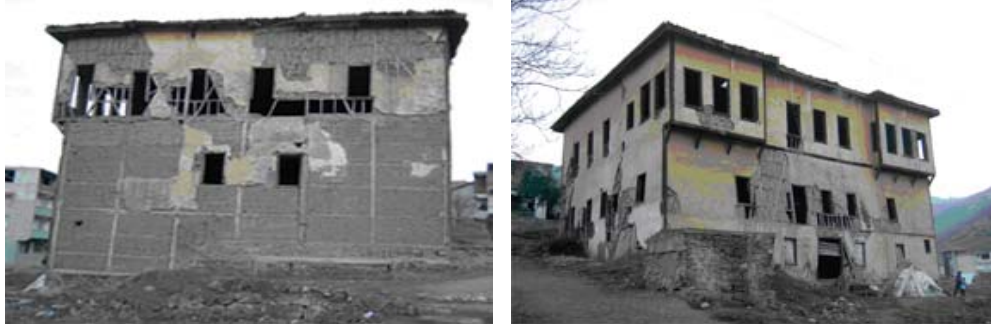
Figure 4. The timber frame with adobe infill construction in Osmaneli.

In Osmaneli, a village near to Adapazarı, traditional forms of construction for dwellings are “hımış” construction. Of the few those “hımış” buildings, most appeared undamaged in the 1999 earthquake. Some damage could be found in shedding of the plaster or fall down of the infill material of the timber frame. There isn't a major destructive crack (Figure 4).

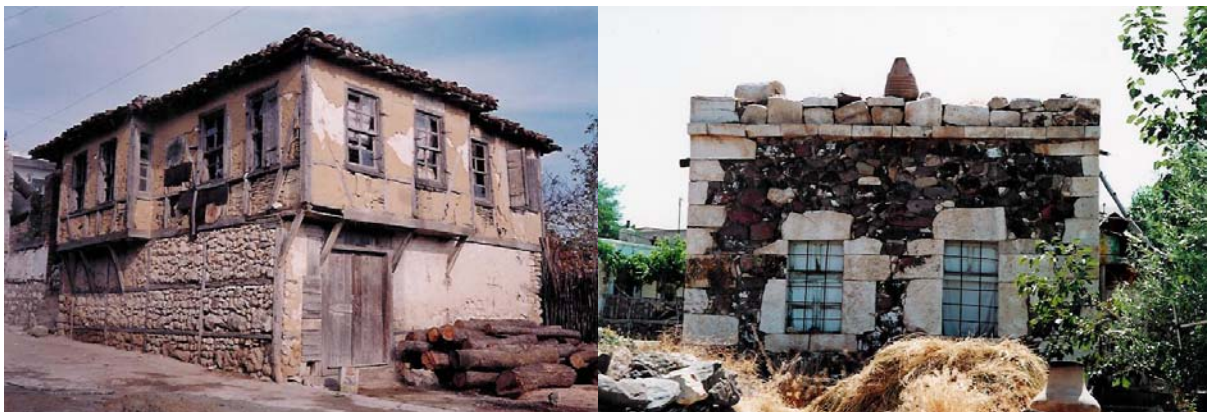
Figure 5. The timber frame construction with masonry infill and masonry construction examples of traditional houses.

Nevertheless, on the regions, where the forest resource is more limited, stone, brick, wood and adobe is used as the filling material of the timber frame (Figure 5).

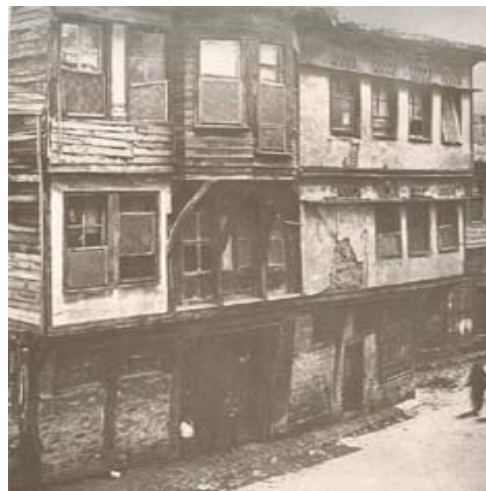
Figure 7. The examples of traditional houses with wood clapboards and “*hımış*” at the beginning of the 19th century in Istanbul (Eldem,1984)

As it is same in other regions of Turkey, the houses in Istanbul were generally plastered “*hımış*” structures until the very beginning of the 19th century. Due to industrial production of the timber and the ease of importing in Black Sea area; from the second half of the 19th century, wood clapboards buildings had taken the place of “*hımış*” structures (Figure 7). This continued until the World War I but later on, as it is the same in all over the world, the timber buildings could not be constructed in Istanbul because of the economic problems after the second half of the 1920’s. (Tanyeli, 1998)

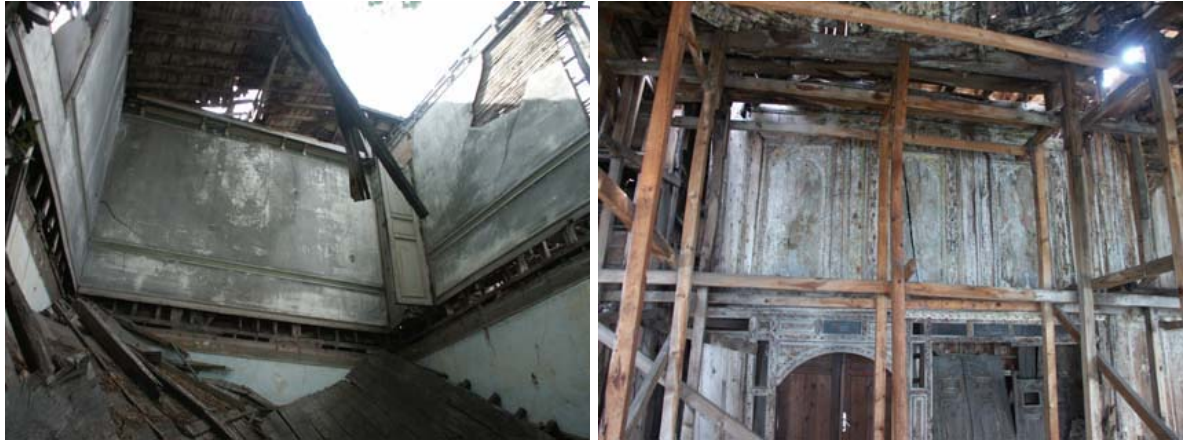
Figure 8. Lack of maintenance: case of Amcazade Yali on Bosphorus.
(Can Binan's archives)

When the historical buildings are examined after the earthquakes, most of them are seen to be abandoned or empty. The timbers of these buildings are rotten or infested by insects. The cause of this damage is lack of maintenance and regular inspections (Figure 8).

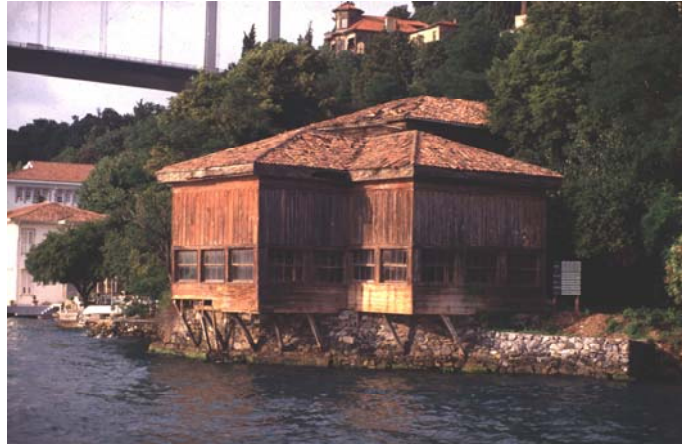
Figure 9. The eldest timber house on Bosphorus: Amcazade Köprülü Yali, 1699

The principles of conservation must always be followed. The most important purpose of conservation is to maintain the historical authenticity and integrity of the cultural heritage (Figure 9). Reinforcing a historic building with new construction methods can destroy a historic building's appearance and structural integrity. Each intervention should be follow for preference:

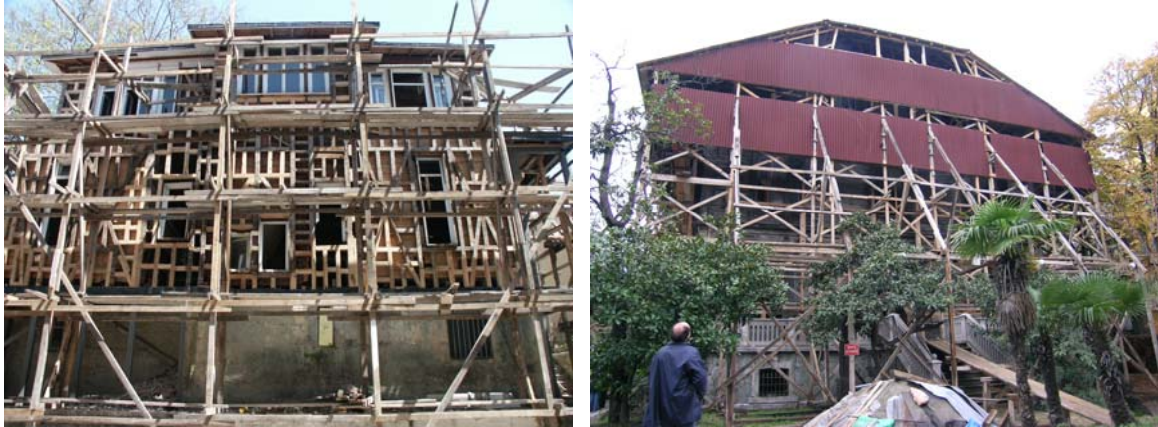
Figure 10. Temporary consolidation of the timber frame structures (Can Binan's archives)

- Strapping of a building: Earthquakes, the shifting of the earth's crust, affect firstly a building through its foundations. For this reason, the analysis of soil and the foundation system should be made. The structure can be bolted to its foundation or the timber frame can be strapped together. While strapping of a building the meeting points of the cables with the building should be cared for. It is necessary to protect original elements to prevent the cable cutting into them. Using wooden angle plates at the meeting points of metal materials and structure is suitable. It is very important how the turnbuckles which provide the tension of strapping cable will be used. The walls must be connected to each other with using braces made from timber, steel, synthetic fibers, etc (Figure 10). We can give additional strength by using plywood stiffeners between the building and strapping cables. By the way, this provides the

structural continuity of a building, and also be used as a plate. Strapping of a building is probably the most common reinforcement method and can be applied to masonry buildings as well. Strapping provides for the building to perform structurally as a whole.

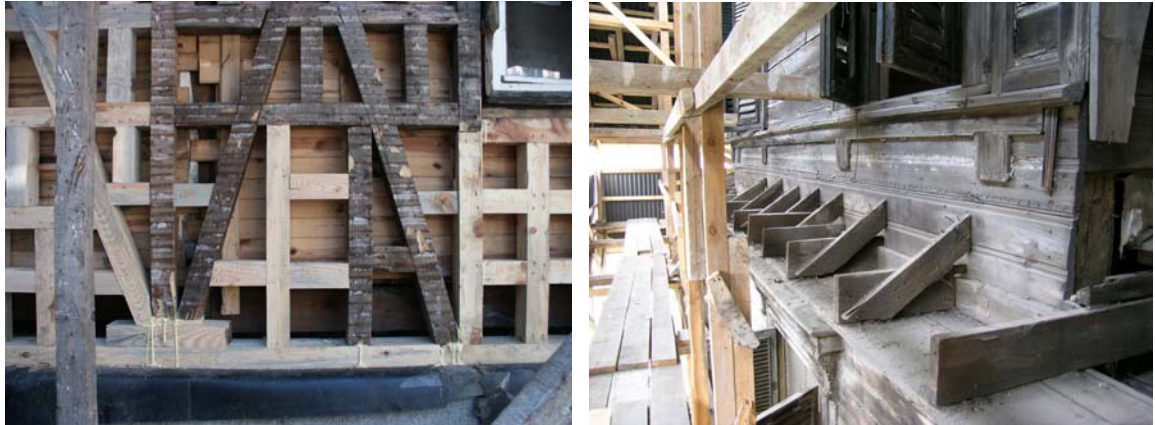
Figure 11. Interior and exterior bracing systems (Can Binan's archives)

- Repair weakened wooden structural systems by bracing existing members: Interior bracing system is always better than exterior ones as they do not ruin the original appearance of the building (Figure 11). Bracing system aim for emergency consolidation after a disaster and must be integrate with the existing structural system of the building. Reinforced bracing should be added in order to have minimal impact and not overload the structural system. The compatible materials should be selected in this system. Timber braces are usually used in historical buildings. Another point that should be cared for is to provide a strong ground as the system transfers the loads to the soil.

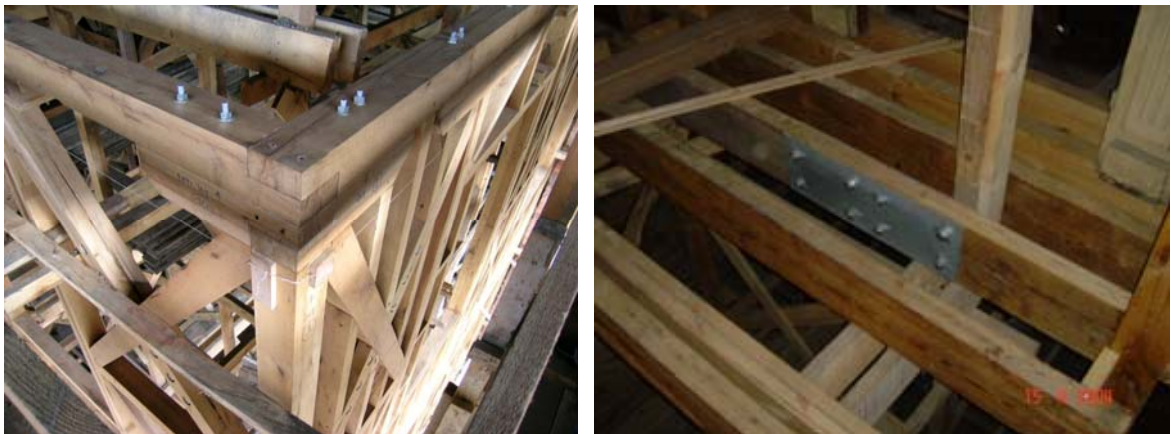
Figure 12. Reinforcing the joints of the timber buildings using mechanical fasteners (Can Binan's archives)

- Reinforcing the joints of the timber buildings between floor, wall and roof connections, column and beam ties using mechanical fasteners like anchor ties or bolts, metal straps, dowels or pegs of wood, metal or glass fiber reinforced plastic, etc (Figure 12). Care should be taken while using these fasteners as the timber elements shrink and expand because of the humidity and the temperature differences. Missing areas of wood can be filled with epoxy resins or other filling materials compatible with the historic character of the building.
