AN OVERVIEW OF THE RECONSTRUCTION PROGRAM AFTER THE EARTHQUAKE OF BAM, IRAN

Mehran Gharaati *

School of Architecture, McGill University

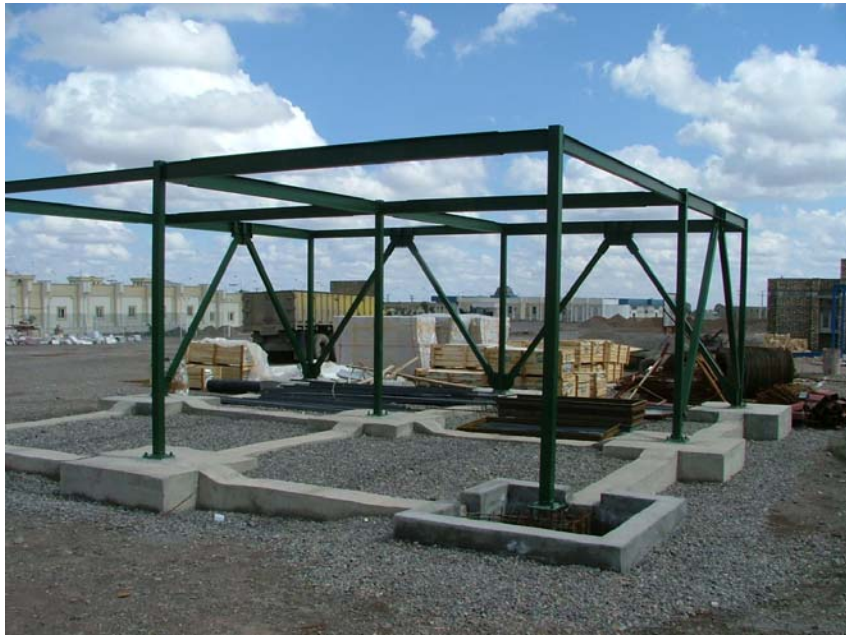
Figure 1: The structure proposed by HFIR

The structure proposed by HFIR consists of prefabricated steel posts, beams, and bracings that are designed in a way that can easily and quickly be assembled, using only bolts and nuts for fastening the elements together. For example, the structure of a regular house ($9 \times 9 \text{ m}^2$, as HFIR recommends) can be installed in place in just few hours, employing only two labourers. Aside from the quick installation, the idea is that using labourers to only fasten the bolts would remarkably reduce the number of failures caused by inadequate welding (Figure 1).

Two factors – quick and easy installation, and resistance to earthquakes – are the main elements of the idea behind the HFIR structural system, which well addresses these concerns. The construction cost, however, remains a major obstacle. In addition to the high price of the prefabricated steel components that are imported from long distances, some parts of the structure are over-designed, which wastes money and materials. For instance, the X and V bracings employed are unnecessarily thick. The 9x9 cm² hollow-section steel bars employed for these bracings can be simply replaced with tiny steel rods or cables, or even a well-done brick wall can do the job. A rough estimation indicates that these bracings constitute around 30 percent of the total steel used in the proposed structure. Moreover, earthquake forces rarely affect one-story buildings if properly constructed. In the case of one-story buildings such as those that HFIR proposes, the placement of thick walls between the steel frames to consolidate the structure against earthquakes would obviate the need for bracings.

Overall, it can be said that the construction method and structure proposed by HFIR is earthquake-resistant to some extent, yet unnecessarily expensive, and employs a technique that is overly sophisticated for the local builders. This method, however, would not resist long enough in earthquake if not properly supervised by an educated inspector of some kind in the roofing stage.

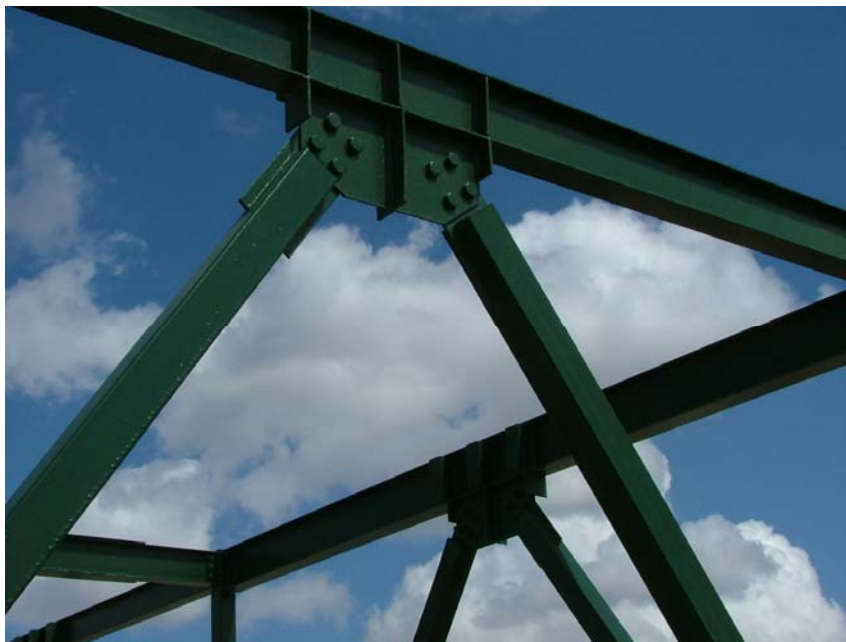
Figure 2: Detail of the HFIR's structure; posts and beams are connected by bolts and nuts

whole structure is placed on a reinforced concrete foundation, to which the frame is connected using bolts and nuts (Figure 2). The roofing system and wall infill technique remain flexible to the constructor/owner's decision. HFIR, however, is building a number of publicly funded buildings, using ordinary bricks and/or hollow blocks as wall infill, and a reinforced concrete slab roofing system.
